**SEISMIC STRENGTHENING OF LOW-RISE UNREINFORCED MASONRY
STRUCTURES WITH FLEXIBLE DIAPHRAGMS**

**A Thesis
Presented to
The Academic Faculty**

**In Partial Fulfillment
of the Requirements for the Degree
Doctor of Philosophy in
Civil and Environmental Engineering**

**Georgia Institute of Technology
May 2004**

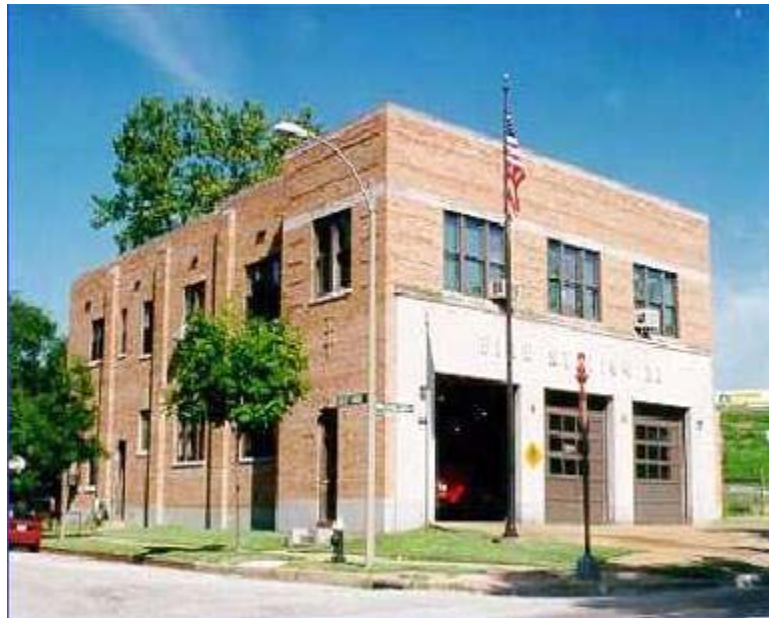
Figure 1.1. St. Louis Firehouse #11 (circa 1950)

The construction of URM buildings in the Mid-America region dates back to the 1770s (ATC, 1997). Typically these structures were built with exterior masonry bearing walls, interior cross walls (either masonry or timber), and flexible timber diaphragms (see Figure 1.1). The masonry walls were commonly composed of sand-lime mortar and solid clay bricks laid in standard American bond with brick headers supplied every sixth or seventh course to connect the wythes. The joints were unreinforced, which results in

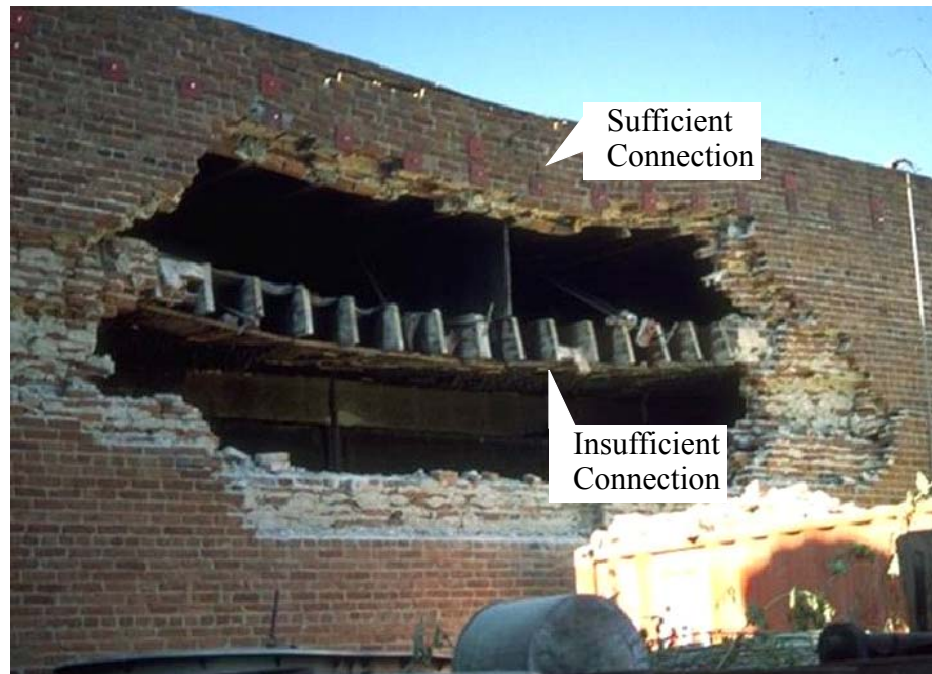
The other common type of connection failure is due to a poor shear connection between the in-plane walls and the diaphragms. In these cases the diaphragm relies primarily on the more vulnerable out-of-plane walls for lateral support. The result is damage to the corners between the out-of-plane walls and in-plane walls, and in some cases the complete collapse of the out-of-plane walls and diaphragm.

Figure 2.2. Typical out-of-plane wall collapse due to insufficient anchorages (taken from www.nisee.org).

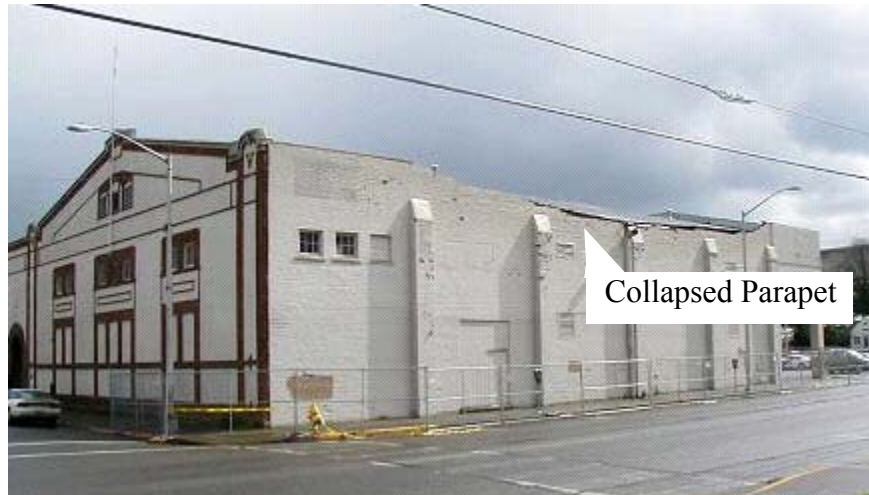
wythe of the wall to behave independently. Other common out-of-plane failures include the collapse of parapets or gables that cantilever above the roof level (see Figure 2.3).

Figure 2.3. Typical parapet failure (taken from www.nisee.org).

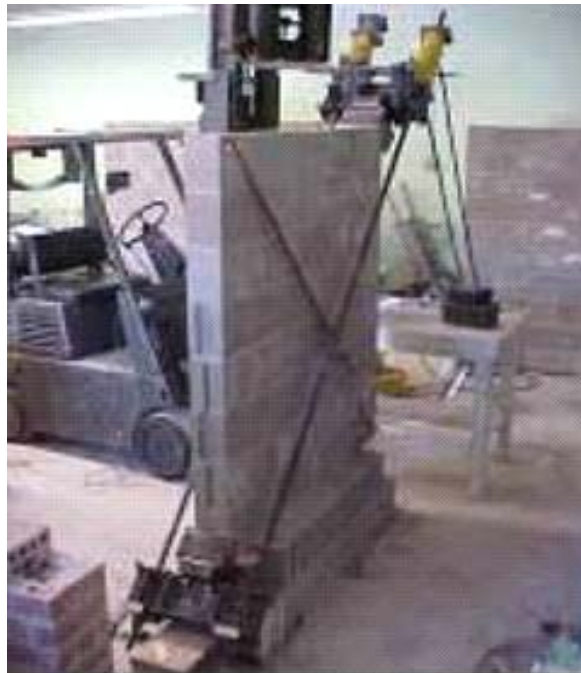
Figure 2.14. Photograph of the in-plane test setup (taken from Tumialam et al., 2002).

Tumialam et. al (2002), subjected five URM piers to in-plane shear in order to assess the effectiveness of structural re-pointing. All five specimens were constructed of a single wythe of 6x8x16 CMU in running bond. The specimens measured 64 in. in length and 64 in. in height. Load was applied to the walls diagonally by a single jack through loading shoes attached to opposite corners of the pier. A photograph of the test setup is shown in Figure 2.14. Table 2.1 gives the type and pattern of reinforcement for each of the specimens tested.

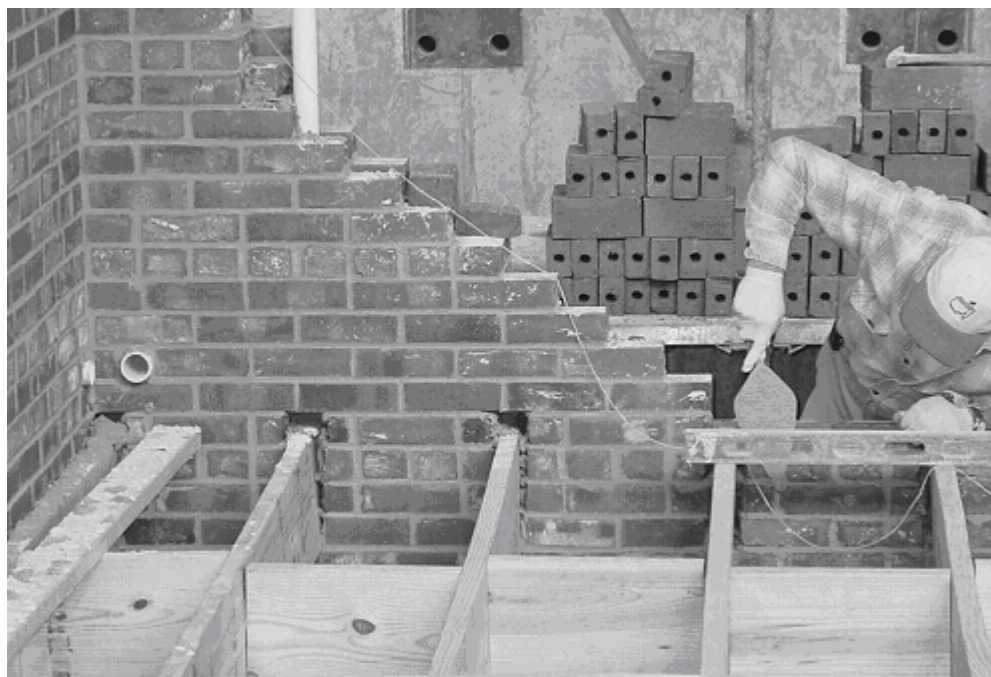
Figure 3.9. Photograph showing the construction of the pocket connection between the floor/roof 2x10 joists and Walls A and B.

The test structure was constructed with two types of shear connections between the diaphragms and URM walls. The first type was formed by placing the joist in a one wythe deep pocket in Walls A and B (see Figure 3.9). This connection detail is commonly found in existing URM structures and transfers shear by the joists bearing against the inside of the pocket. The second type of shear connection consisted of 5/8 in. diameter threaded rods cast into Walls 1 and 2 with nonshrink grout. These rods were then bolted to the joists directly adjacent to the wall (see Figure 3.10). In many cases this connection is considered a retrofit measure; however, the structure was constructed with these connections to facilitate the testing of the diaphragm. These connections were spaced 48 in. on center and 24 in. from the edges of Walls 1 and 2. This spacing represents a maximum allowable spacing as given by FEMA 178 (ATC, 1997).

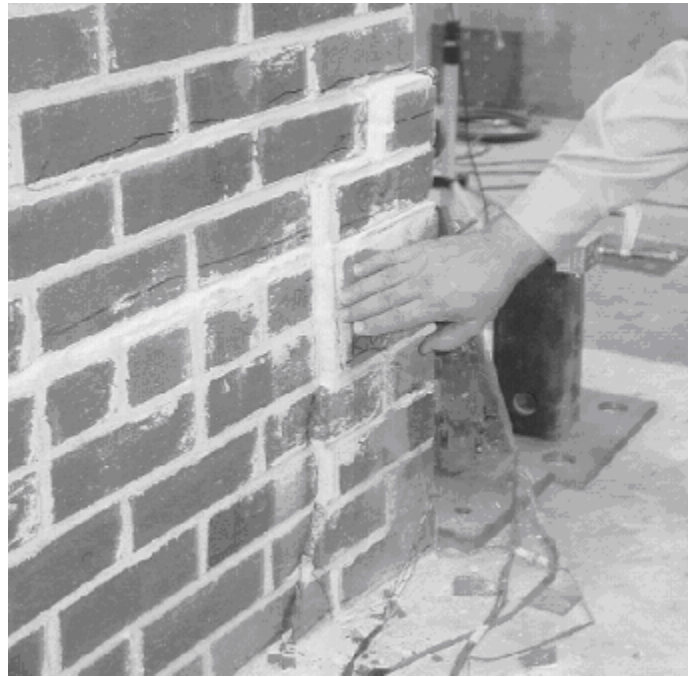
During Test Run 17 the sliding deformation of pier P1-6 caused the lower eight courses of Wall 1 to punch through Wall B (see Figure 4.12). A photograph of this damage following Test Run 19 is shown in Figure 4.13. During Test Run 18 a crack along the base of pier P1-7 formed and propagated into out-of-plane Wall A. During Test Run 19, an additional crack formed diagonally in pier PB-10 and propagated horizontally along the top of the first story piers in Wall B.

Figure 4.13. Pier P1-6 punching through Wall B.

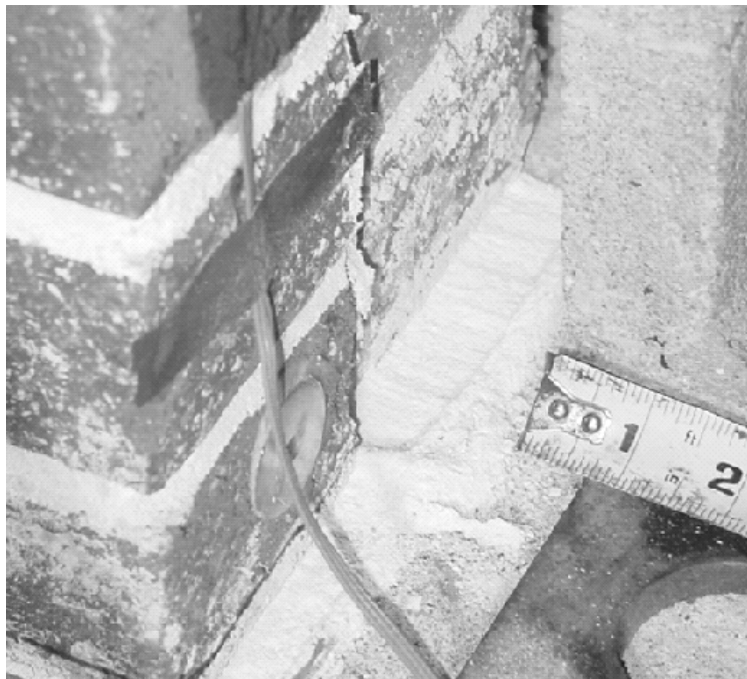
Figure 4.14 shows a photograph taken of pier P1-6 along the inside of the door opening during Test Run 19. This figure illustrates that the observed sliding deformation reduced the mortar in the adjacent bed-joint to a white powder. This powder was observed along the entire base of pier P1-6. One possible explanation for the decrease in base shear capacity during these cycles is that this damage to the bed-joint along the sliding plane

In addition, this figure illustrates that the wythes in pier P1-6 separated during loading. Note that this separation occurred below the first header course (sixth course). This separation was likely caused by the GFRP reinforcement only being applied to the inside wythe and highlights the need for such reinforcement to be developed into multiple wythes. Above the sixth course no separation was observed, and thus it is concluded that the header courses provided sufficient shear transfer between wythes.

Figure 4.14. Photograph showing the sliding deformation of pier P1-6 along the inside of the door opening.

As mentioned previously the decrease in base shear resistance is primarily attributed to the grinding of the mortar joint along the active sliding plane shown in Figure 4.14. Another factor that likely contributed to the strength decrease was the

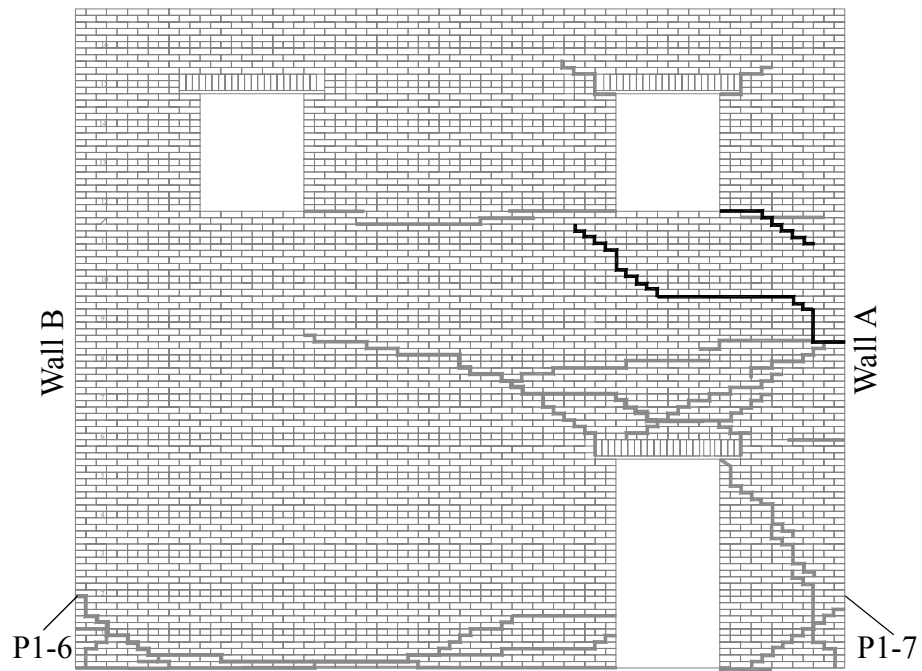
Figure 4.49. Crack pattern of Wall 1 following Test Run 26.

The crack pattern of Wall A and out-of-plane Walls 1 and 2 following Test Run 26 are shown Figures 4.48 through 4.50. Note that the cracks that formed during Test Runs 20 through 26 are shown in black and those that formed during past cycles are shown in gray. Figures 4.51 and 4.52 show schematics illustrating the final mechanism of Wall A and out-of-plane Walls 1 and 2 prior to post-tensioning in the positive and negative directions, respectively.

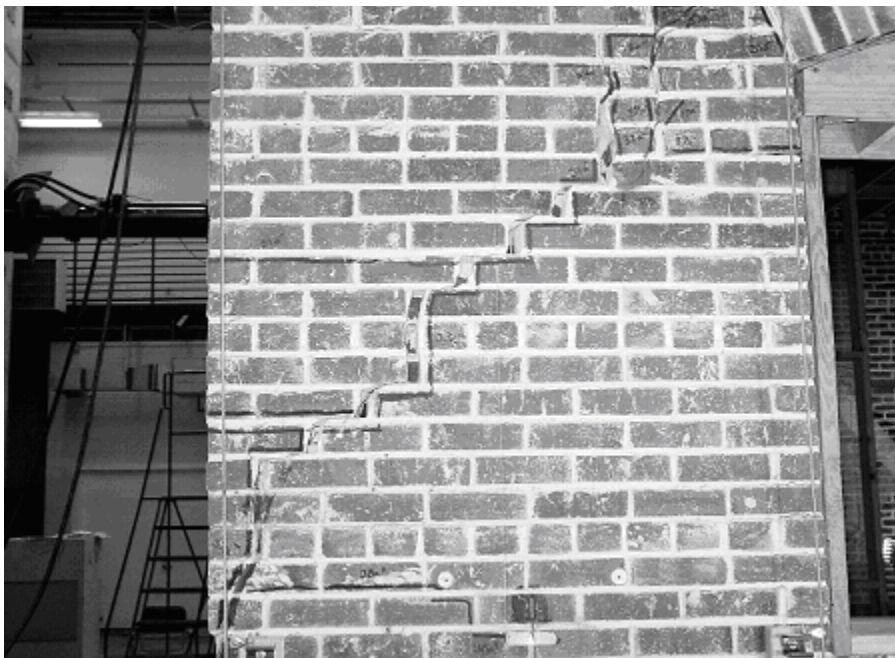
Figure 4.64. Diagonal Crack observed in pier PA-7 following Test Run 39.

Test Run 37 the diagonal crack in pier PA-7 became fully developed and propagated to the length shown in Figure 4.57. A photograph of pier PA-7 taken after Test Run 39 is shown in Figure 4.64. Additional vertical cracks were observed in Wall 1 below the second floor level during Test Run 39. These cracks extended from the bottom of the second floor actuator down to existing vertical cracks in pier P1-7 and suggested that the entire first story of Wall A was punching through Wall 1.

The progressive opening of the diagonal cracks above piers PA-7 and PA-10 is attributed to overturning moment and was discussed in Section 4.3.1.2. In contrast, the progressive opening of cracks in the center of pier PA-7 and the lower portion of pier PA-9 is attributed to unsymmetrical pier behavior. In these cases overturning moment may have played a role; however, the unsymmetrical pier failure mode was the primary cause. For example, pier PA-9 displayed varying degrees of rocking/sliding behavior in both directions; however, the active cracks were different in each direction (see Figures 4.60 and 4.62). This resulted in a progressive growth of the diagonal crack at the base of pier PA-9 (see Figure 4.63). The diagonal crack in pier PA-7 opened in a similar manner and is shown in Figure 4.64.

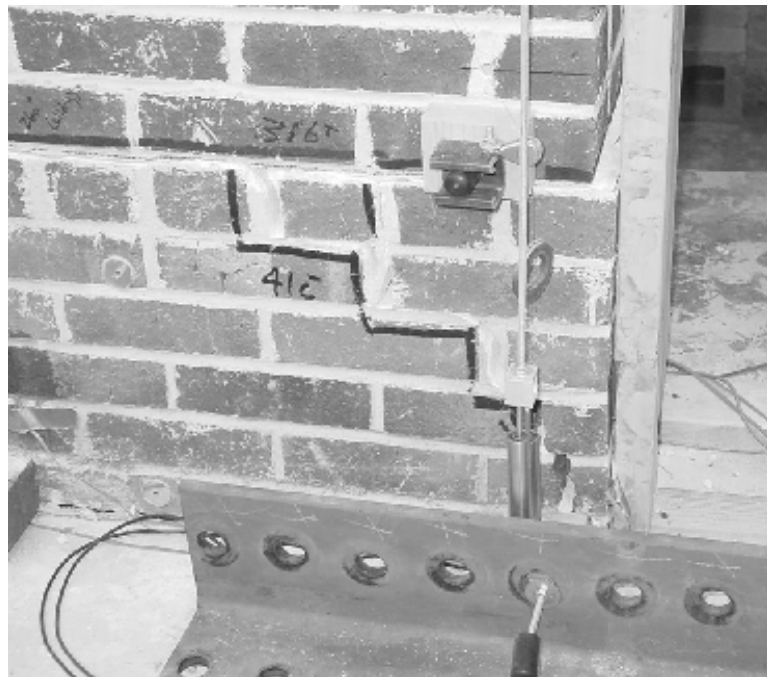
Figure 4.89. Horizontal and diagonal crack at the base of pier PB-7 following Test Run 41.

During Test Run 41 two cracks formed in the spandrel above the door opening and propagated to the arch lintels above both window openings. Also during this test run at a roof displacement of approximately 1.3 in, the lower corner of pier PB-7 separated from the remainder of the pier causing the pier to abruptly rotate downward and slide along the base (see Figures 4.88). Essentially, the rotation of the pier was recovered and translated into sliding deformation. Figure 4.89 shows a photograph of the lower right corner of pier PB-7 taken after Test Run 41.

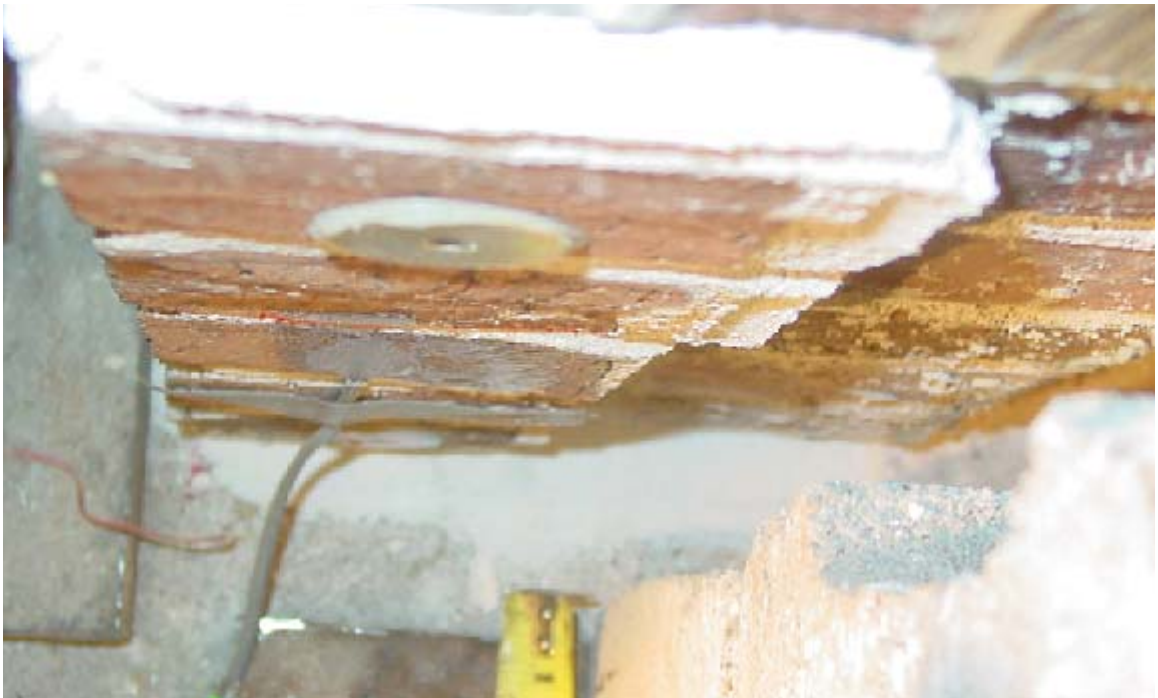
However, this smooth crack only formed on the inside wythe. Since the first header course was located at the sixth course, the reinforcement was not developed in the outer wythe below this point. The result was a vertical crack through the collar joint below the first header course. This crack allowed independent movement of the wythes at the base of the pier. This was observed most clearly at the door opening (see Figure C.46);

Figure C.46 Photograph showing the separation of the wythes below the first header course.

however, based on observed crack opening this phenomenon was likely occurring at the lower left corner of pier P1-6 as well. Above the sixth course no separation of the wythes was observed, which suggests that the header courses performed properly throughout loading.

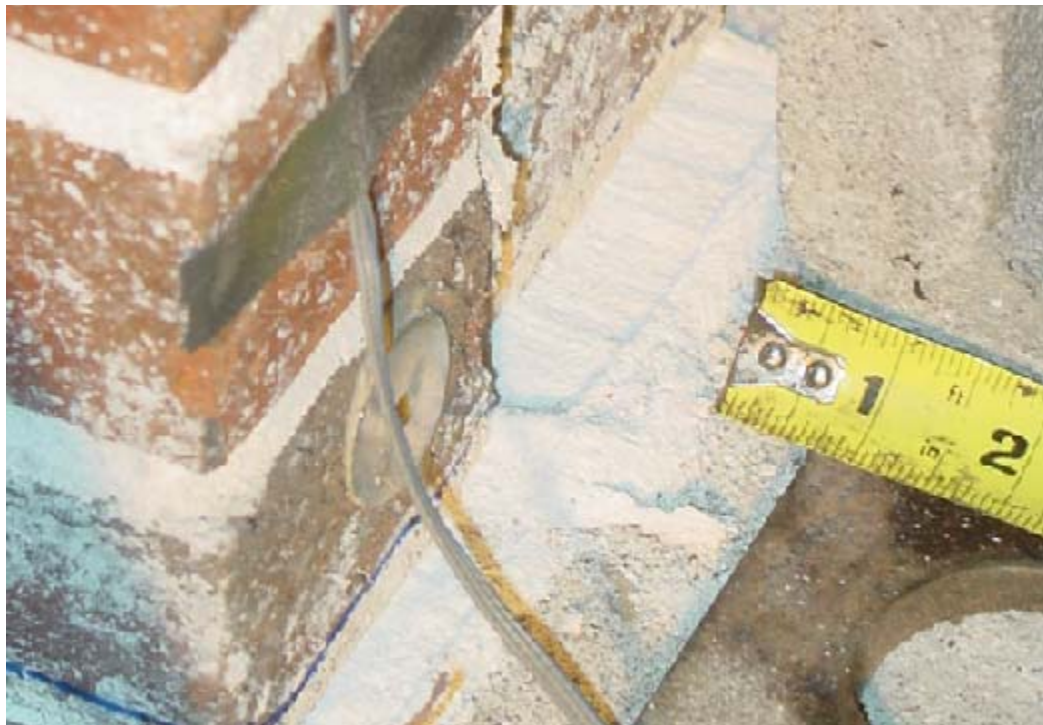
Figure C.55 Photograph showing the resulting white powder from the bed-joint at the base of pier P1-6

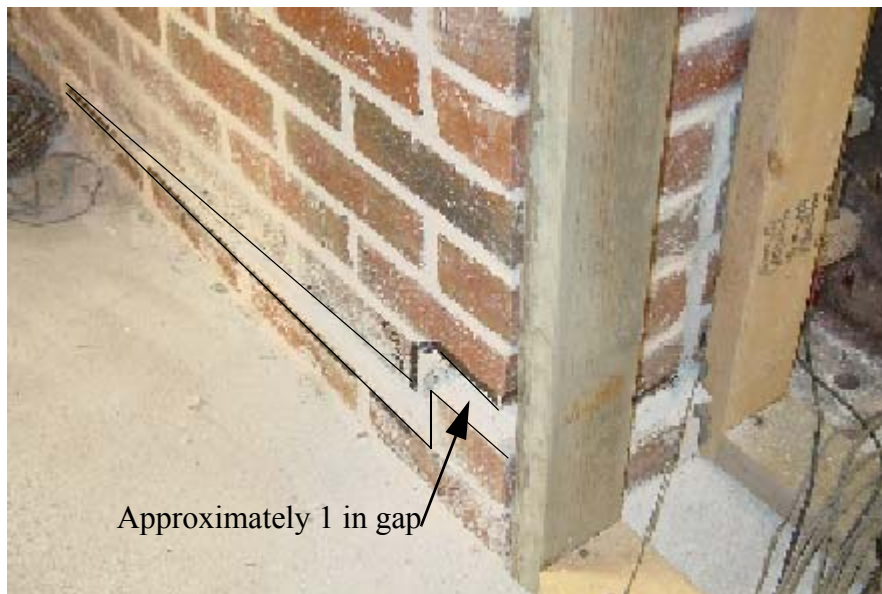
Figure E.72 Photograph illustrating the residual out-of-plane rotation of pier PA-10 following Test Run 39 (taken from inside the structure).

figure, the out-of-plane rotation of the piers was permanent. Following Test Run 39, the out-of-plane rotation of pier PA-10 caused a permanent offset of approximately 1 in at the inside of the door opening. Figure E.72 shows a photograph of this displacement.

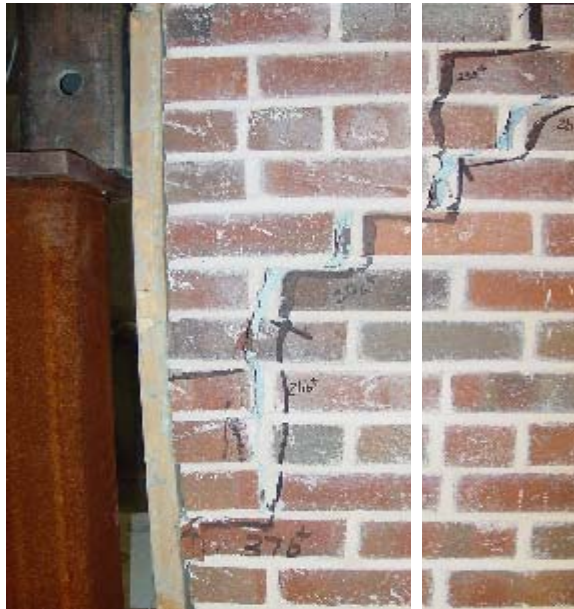
Figure E.74 Photograph illustrating the permanent displacement of pier PA-9 following Test Run 39 (photo taken from inside the structure).

In addition, unsymmetrical pier behavior also caused progressive crack opening in two locations. Specifically, the center of pier PA-7 and the lower portion of pier PA-9. In these cases overturning moment may have played a role; however, the unsymmetrical pier failure mode was the primary cause. For example, pier PA-9 displayed varying degrees of rocking and sliding behavior in both directions; however, the active cracks were different in each direction (see Figures E.65 and E.69). Essentially, the lower portion of pier PA-9 was displaced laterally in the positive direction due to sliding and in the negative direction the pier displayed rocking/sliding deformation about a different crack. This resulted in a progressive growth of the diagonal crack at the base of pier PA-9 (see Figure E.74). The diagonal crack in pier PA-7 opened in a similar manner and is shown in Figure E.75.

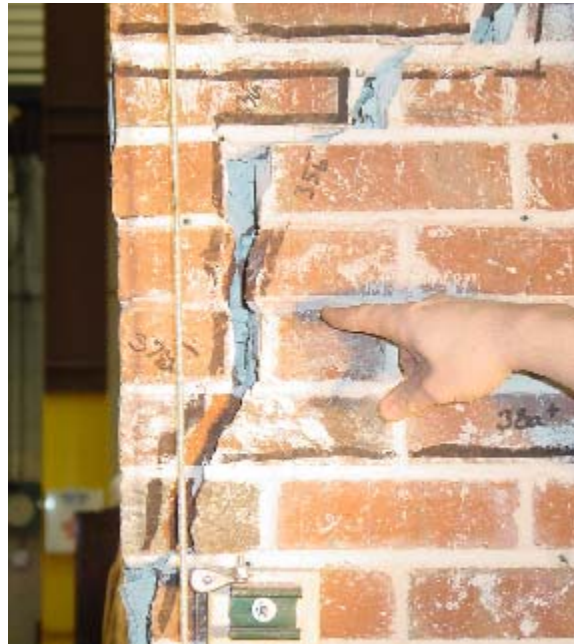
Figure E.75 Photograph showing the residual crack opening of the diagonal crack in pier PA-7 following Test Run 39.

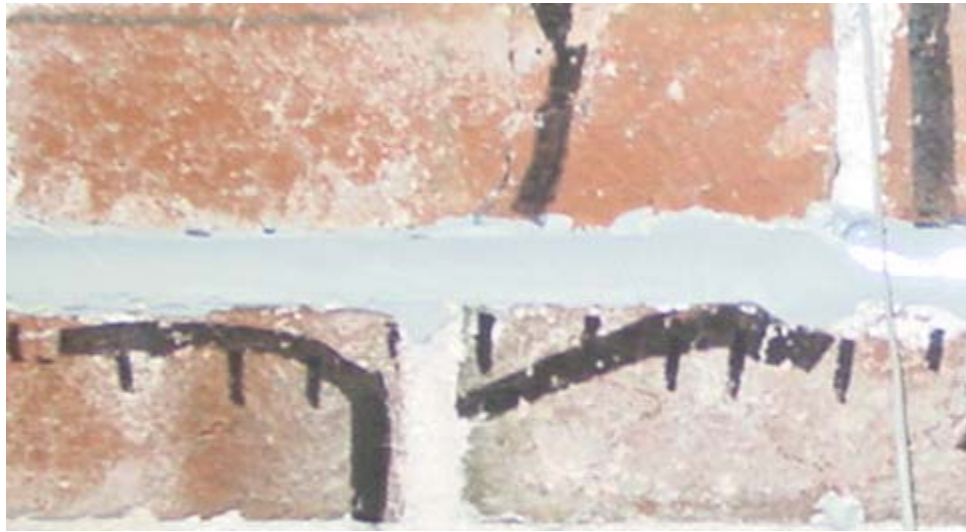
Figure F.48 Photograph illustrating the observed damage in the NSM rods following Test Run 33.

During this level of testing, visual damage was observed in both the FRP overlays applied to the inside of the wall and the NSM rods applied to the outside of the wall. In the case of the NSM rods, the damage consisted of hairline cracks in the matrix aligned perpendicular to the axis of the reinforcement (see Figure F.48). This damage was observed along the active diagonal cracks above piers PB-7 and PB-10 (see Figures F.43 and F.46). In many cases, several hairline cracks were visible in the epoxy suggesting that the NSM rods had debonded from the adjacent masonry (see Figure F.48). The distance between the observed cracks in the epoxy was approximately 1 in in nearly all cases.

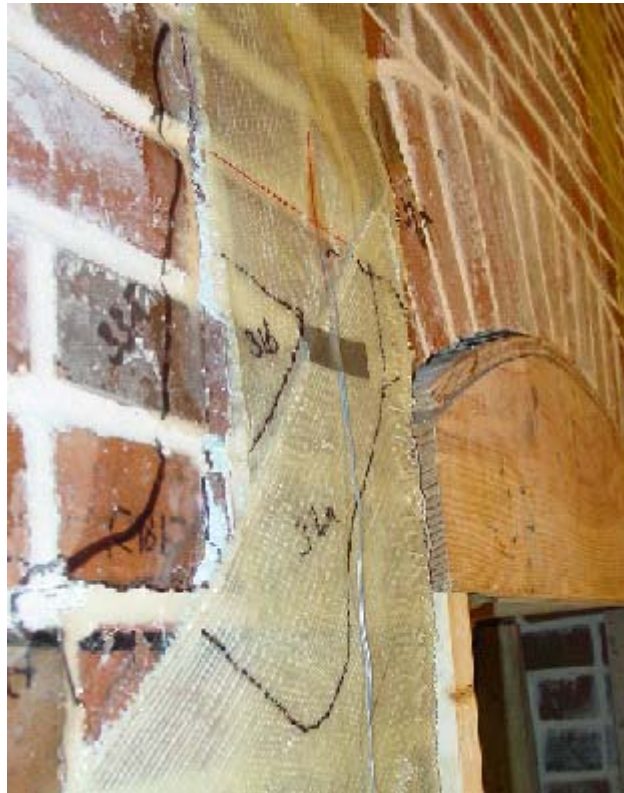
Figure F.49 Photograph illustrating the observed damage in the FRP overlays following Test Run 33

Similarly, the observed damage in the FRP overlay system can also be characterized as a debonding of the reinforcement. Figure F.49 shows a photograph of a debonded region following Test Run 33. Based on visual observations, this debonding failure can be classified as a cohesive failure of the masonry substrate. This failure was likely caused by local strain concentrations in the reinforcement directly adjacent to the active cracks illustrated by Figures F.43 and F.46. These strain concentrations resulted in large tensile stresses in the overlays, which in turn caused large shear stresses in the adjacent masonry substrate. As the displacement of the wall was increased, these shear stresses exceeded the surface shear strength of the masonry and resulted in the failure illustrated by Figure F.49.

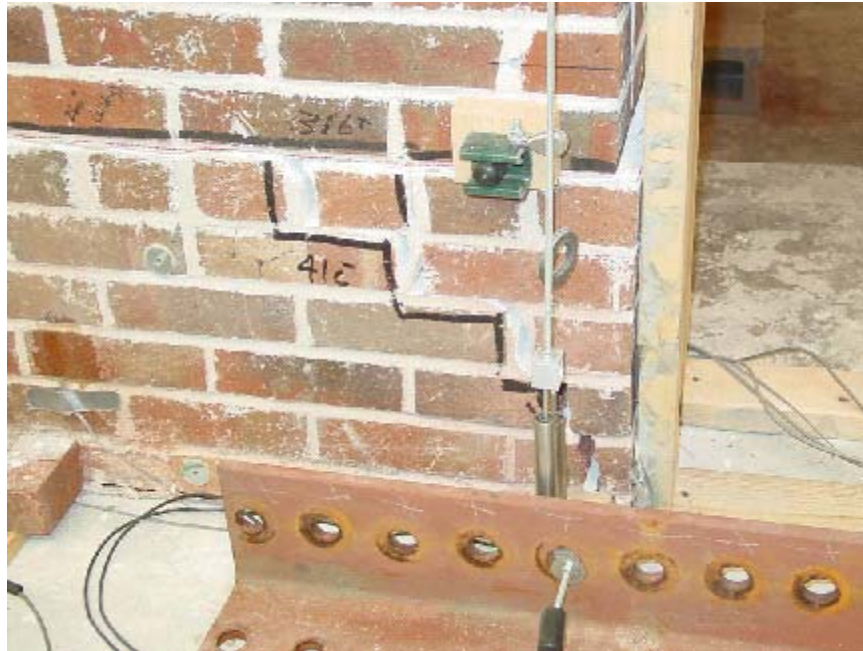
Figure F.93 Photograph showing the damage observed in the lower corner of pier PB-7 during Cycle 41c.

In addition, during Cycle 41c pier PB-7 underwent a fairly dramatic change in behavior. At a roof displacement of approximately 1.3 in, the lower corner of pier PB-7

separated from the remainder of the pier causing the pier to rotate downward and slide along the base (see Figures F.92 and F.93). Essentially, the rotation of the pier was recovered and translated into sliding deformation. This evolution of behavior occurred suddenly and was accompanied by a loud deep bang.

Similar to the behavior in the positive direction, the global rocking shown in Figure F.90 engaged portions of out-of-plane Walls 1 and 2. Figure F.91 shows a plot of the base strains recorded at peak negative displacement during Cycle 41a. Similar to past cycles, this figure supports the contention that pier P1-6 was participating in the response. In addition, this figure indicates that the toe of pier PB-7 was experiencing relatively large strains during Cycle 41a. Recall that during the following cycle (Cycle 41c), the damage illustrated Figure F.93 in was observed in this region.
